City of Plattsburgh Crete Memorial Civic Center *Assessment Report*

April 2016

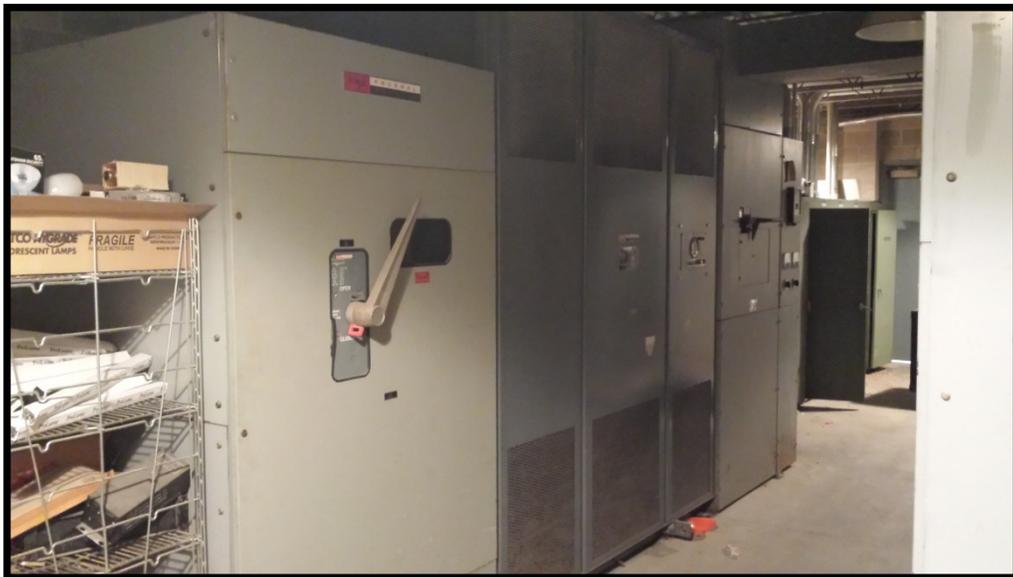
Existing 5kV switch, 1500kVA Transformer (4160/277/480V), & 2000A Secondary Disconnect

The electrical equipment in the building is 1970s vintage and has reached the end of its useful life. It is recommended that the medium- and low-voltage equipment be replaced with new equipment. Some of the building lighting has been upgraded, but most fixtures are still older technology (incandescent) fixtures. It is recommended all the lighting be replaced with LED fixtures to lower the building's energy consumption. Energy savings incentives can also be obtained from NYSERDA. The existing lighting control panel shall be replaced with a new lighting

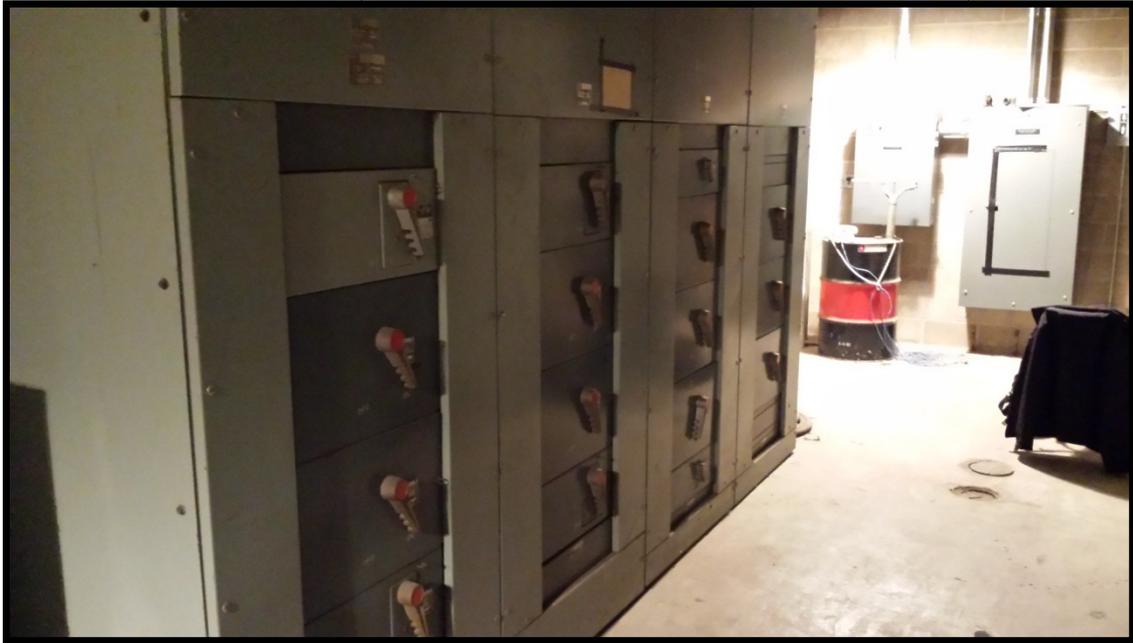
Existing 2000A, 277/480V, Fused Distribution Switchgear

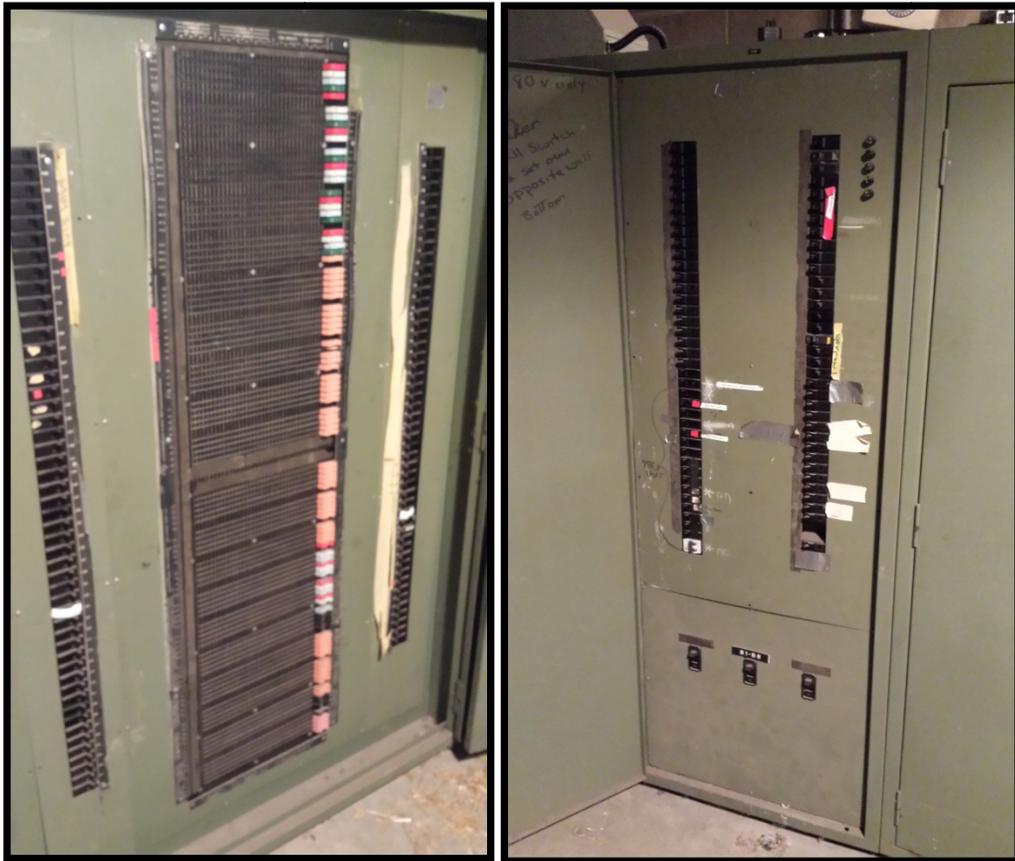
In the main electrical room, there is a 277V Arena Lighting Control Panel that controls the lighting throughout the open arena space. Some of the lighting has been updated from the original design and the lighting control panel is not used to its full capacity, as it once was.

Existing Lighting Control Panelboard

control panel, utilizing relays for lighting control. The new lighting control panel will have a much smaller footprint when compared to the existing equipment. Receptacles and wiring within the building are mostly original and have reached the end of their useful lives and are recommended to be replaced as well. In-floor receptacles should not be used until they are replaced in their entirety (receptacles and wiring). One minor violation may be the need for GFI-protected circuits for the floor-mounted receptacles, in case they wash the floor after RV shows, etc. Currently installed floor boxes have gotten wet in the past and are now rusted and could become a life safety hazard if they become wet.

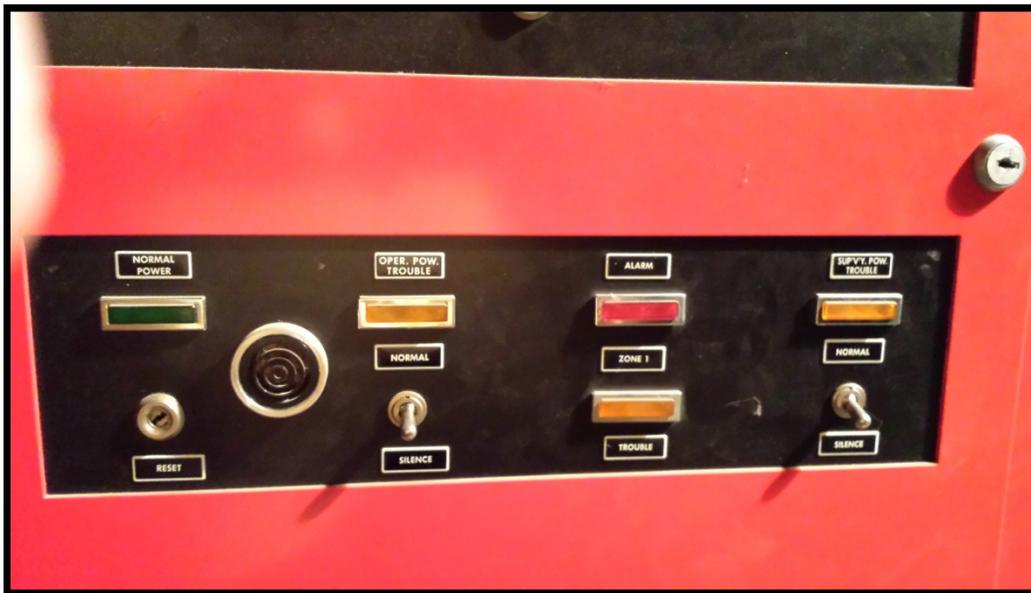
The fire alarm system is a zoned system and is original to the building. Some fire alarm devices have been updated throughout the facility.

Existing Zoned Fire Alarm Panel

The fire alarm system is recommended to be replaced with an addressable system, meeting current building code and NFPA standards.

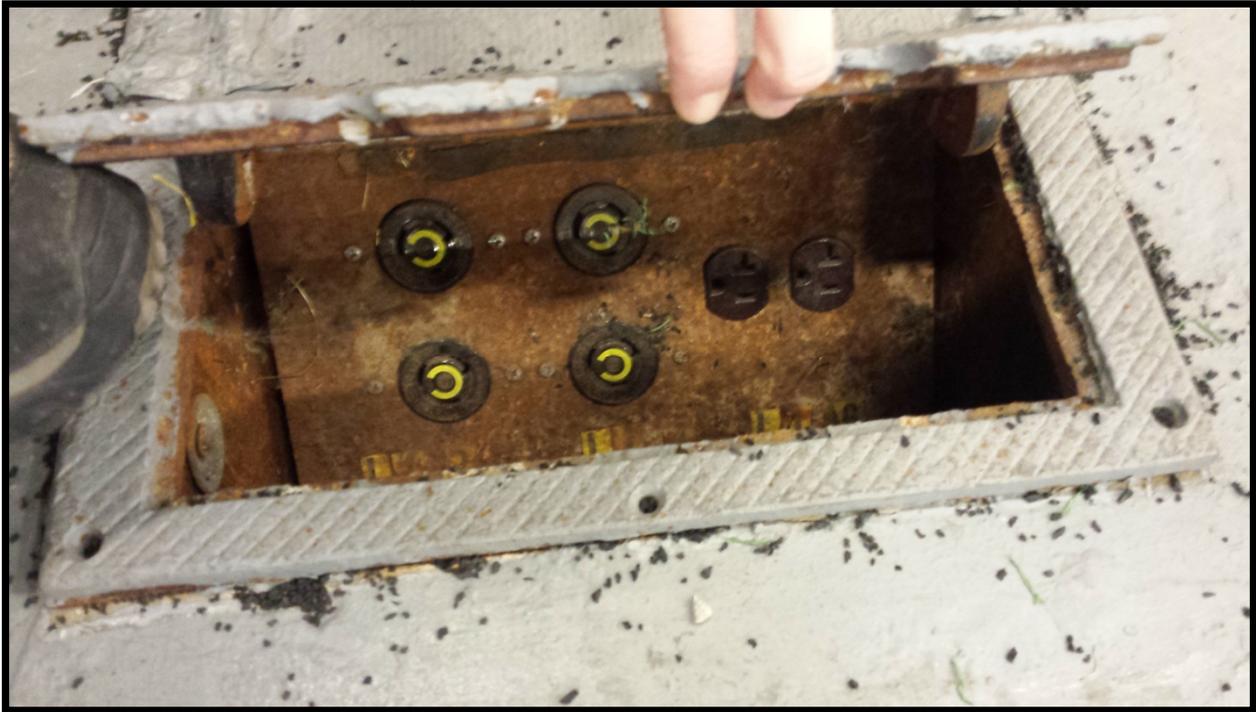
Existing in-slab electrical outlets and enclosures, which continue to get used, are well past their useful life, have been damaged by water intrusion, and are a life safety hazard. The receptacles are in poor condition, as is the cabling feeding them.

Existing In-Floor Receptacle Enclosure

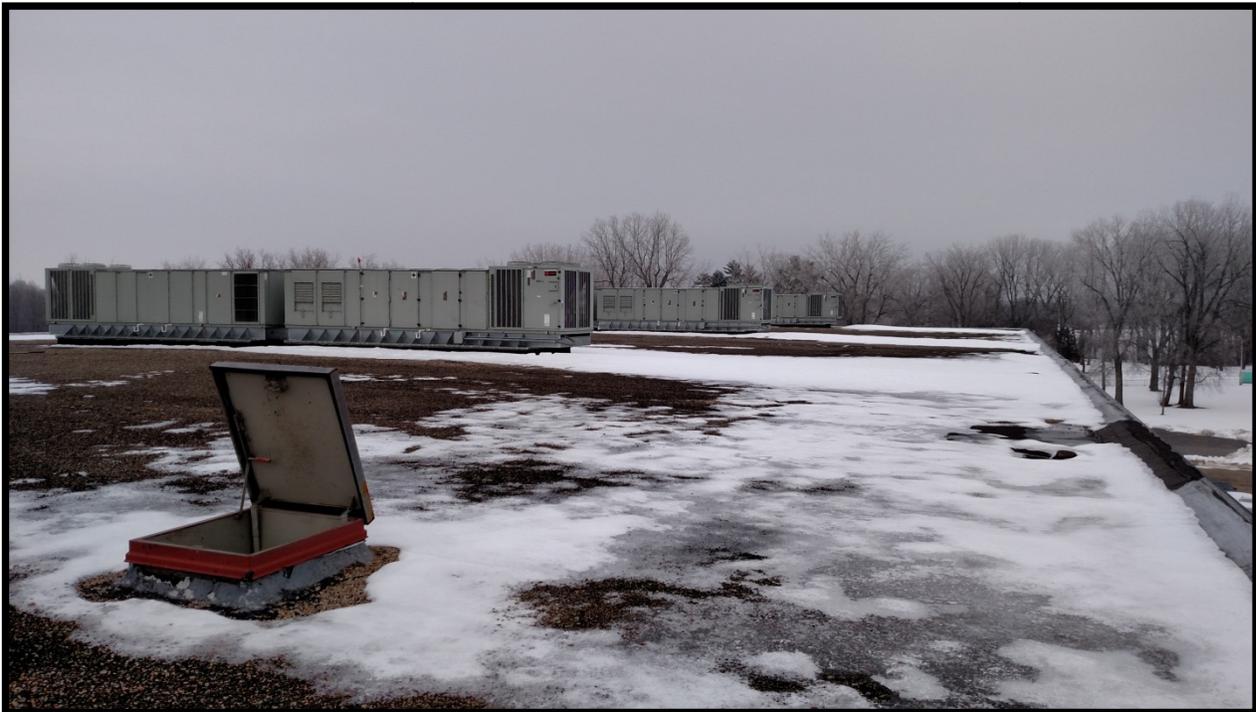
The building is primarily served by six (6) electric roof top units (RTU) (Trane Intellipak, Model SHE) that condition the large 25,000 ft² open field area. The units are in good condition with some minor disrepair issues such as deteriorating seals around some of the roof curbs and some damaged damper blades. The interior of the units is in good condition; the coils and filters are clean and appear to have been well-maintained. The fan motor belts are tight and the coil drain pans are generally in good condition with all the P-traps functioning as intended.

Existing Roof Top Units (RTUs)

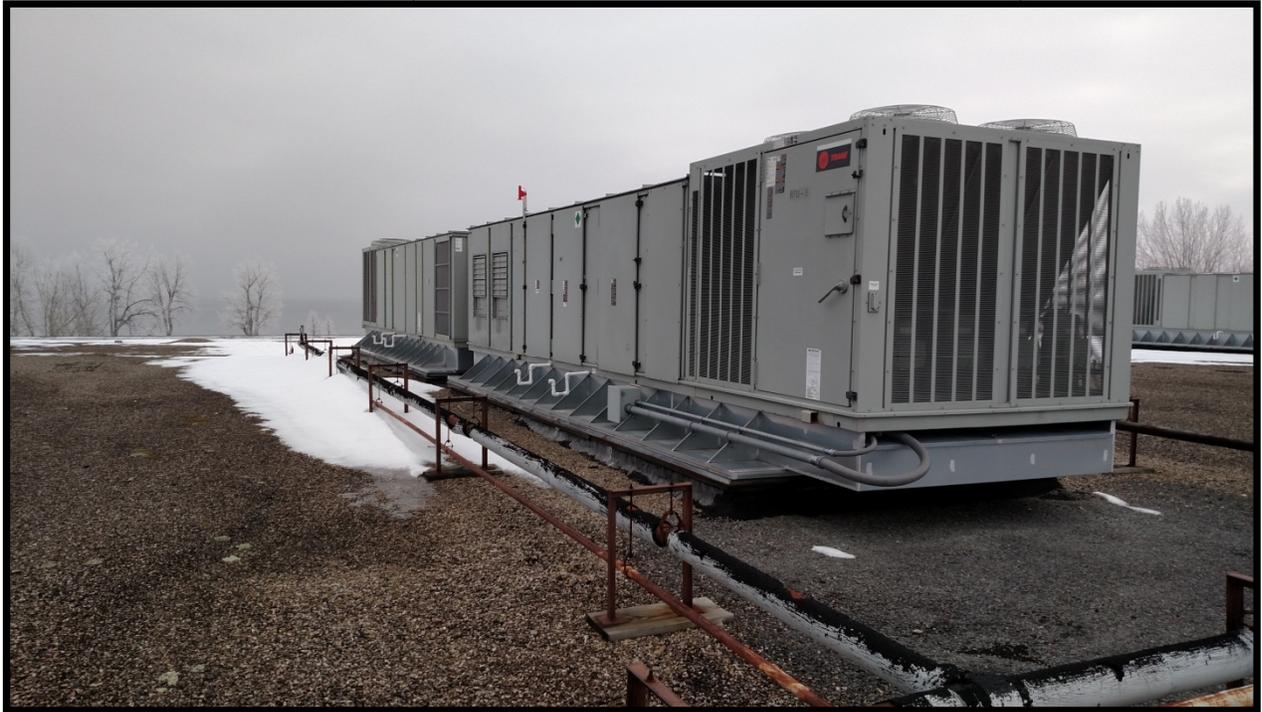
Existing RTU and abandoned piping

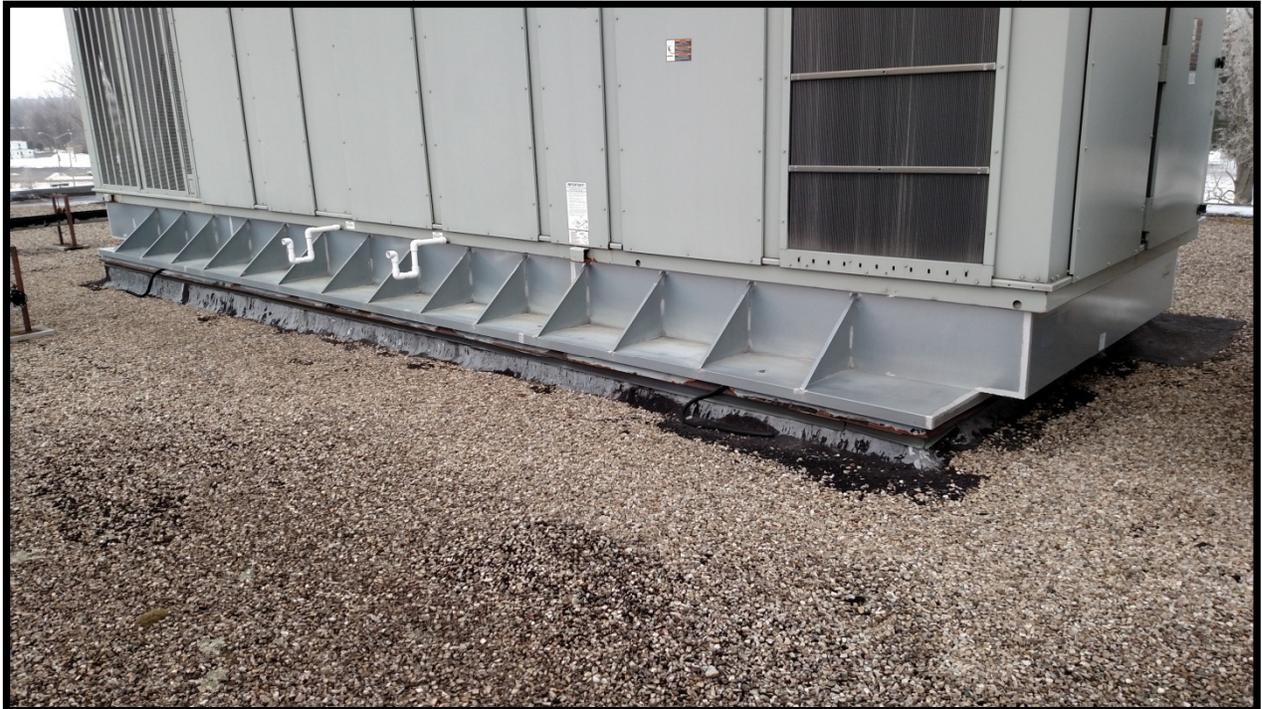
Existing RTU and showing curb seal deterioration

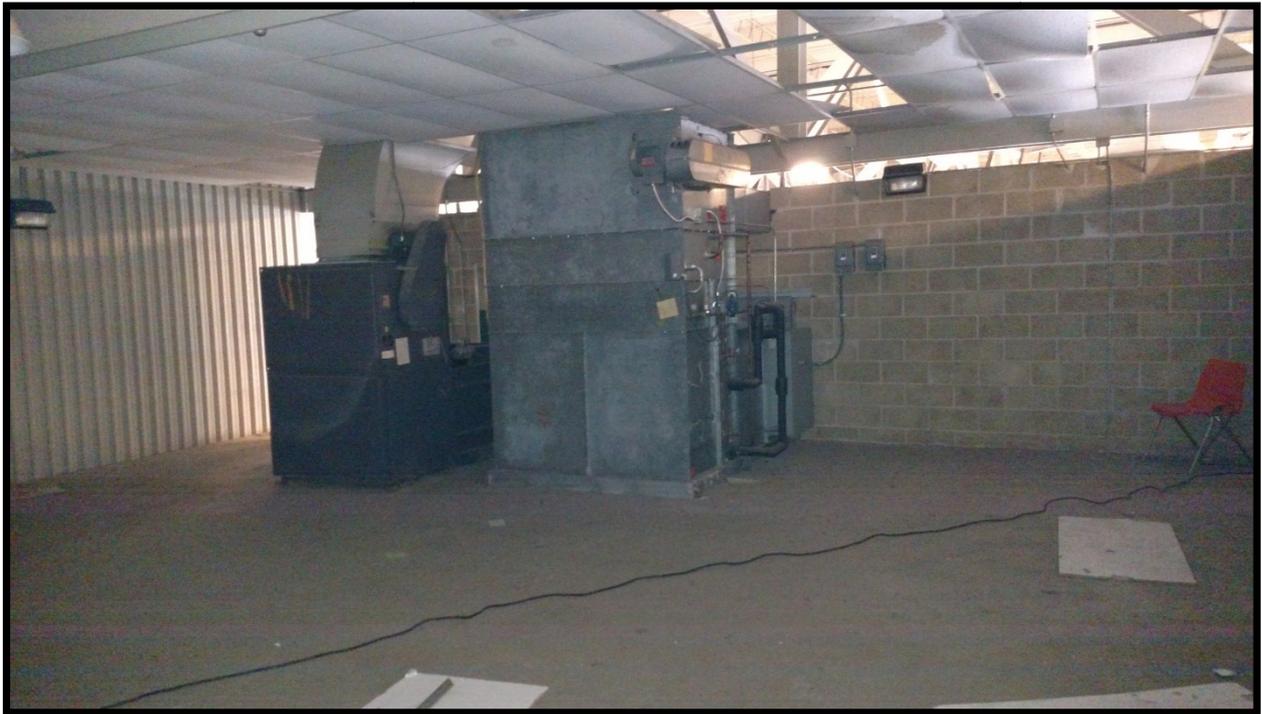
There are two electric dehumidifiers (Buffalo Forge Model J, Size 60VPO), one on the second floor storage space and one on the catwalk at the opposite end of the building. They are in average cosmetic condition, are believed to be operational, but are well past their useful life expectancy. The units were utilized for removing humidity during the era that the building was used as an ice rink and currently serve no function.

Outdated air handling unit (AHU) and dehumidifier

Overall, with the exception of the six (6) large, aforementioned RTU's, the heating/cooling equipment of the facility is generally beyond its useful life and will need to be upgraded in a future capital improvement project. The existing HVAC equipment does not meet the energy code requirements by today's code standards. If the building is going to be reused, the equipment will have to be replaced.

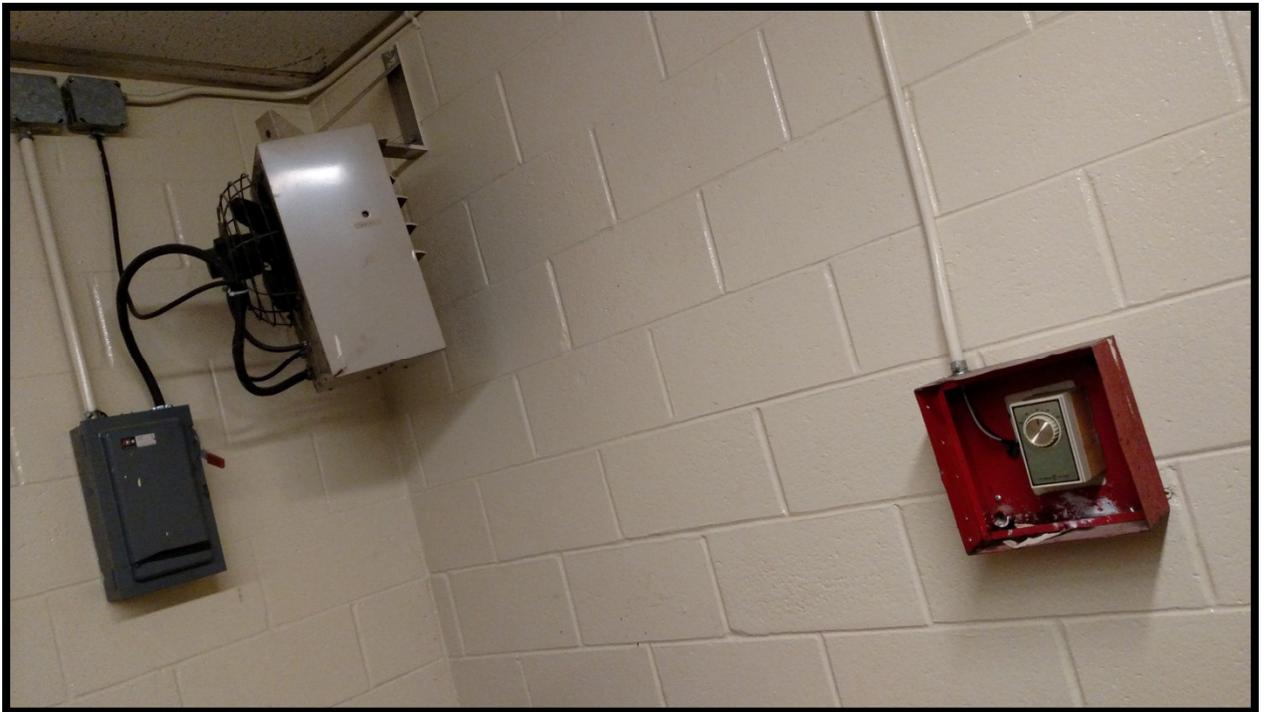
Existing unit heater and thermostat. Unit heater incorrectly pointed towards wall

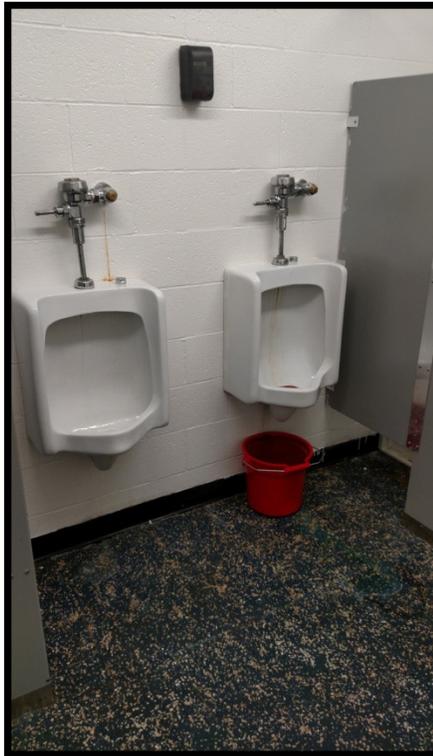
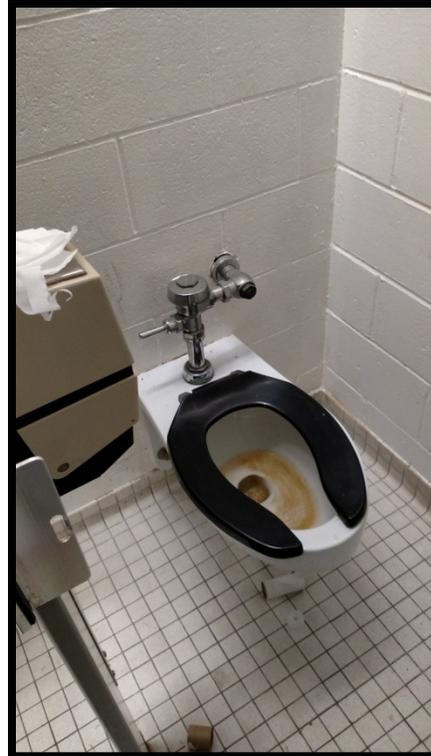
Most of the locker/shower areas have significant plumbing fixture condition issues. A lot of the water closets, urinals, sinks, gang showers, and lavatories, non-operable, in some areas have been removed altogether, with large gaping holes left in their former location. Missing plumbing fixtures would constitute a code violation.

Existing outdated plumbing fixtures.

Most of the sanitary waste and drain piping is corroded and should be replaced if it is decided that the facility will be repurposed or renovated. The plumbing system, in its current condition, is not suitable for supporting the expected building functions.

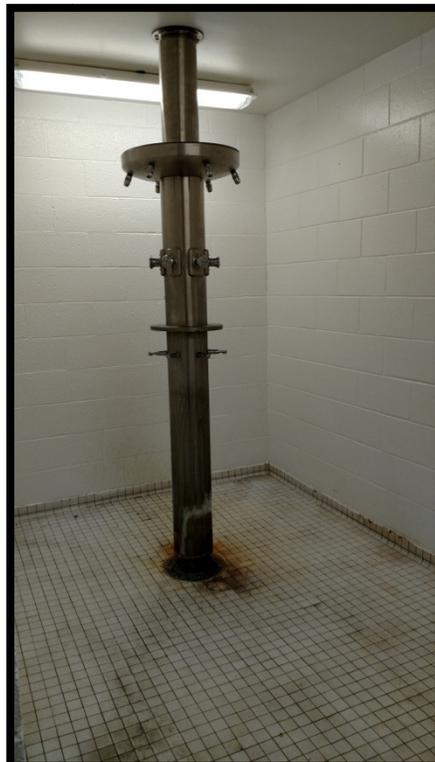
Typical gang shower area showing shower fixture with significant rusting

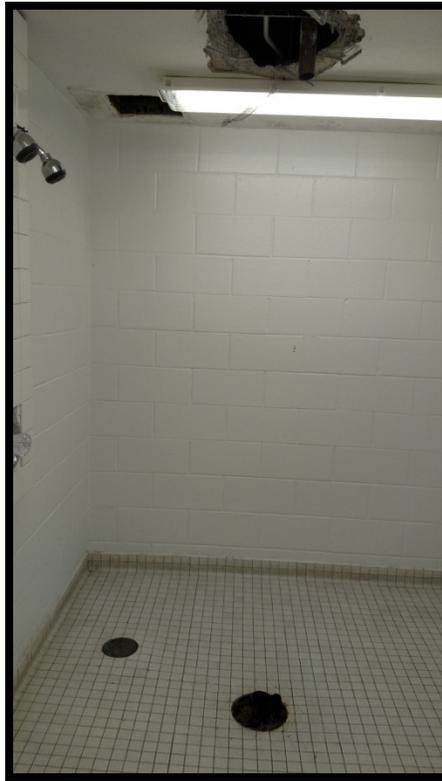
Typical gang shower area showing shower fixture that has rusted away

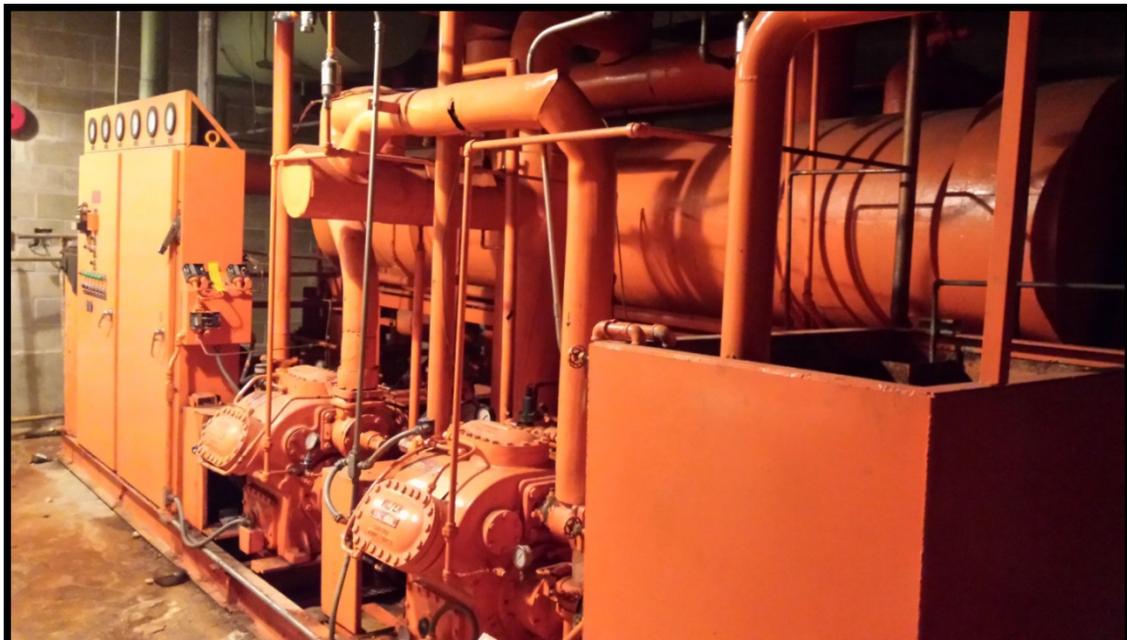
The building originally had an ice rink that is no longer used and has been converted to a turf soccer field. The ice making equipment is still located in the mechanical room, abandoned in place. It is original to the building (1972), well beyond its useful life, has not been operated or maintained for several years, and is presumed to be nonoperational.

Abandoned in place ice making equipment
